Home Inspection Report

W1111 , Nelson , WI 54756

Monday November 20, 2017

1290

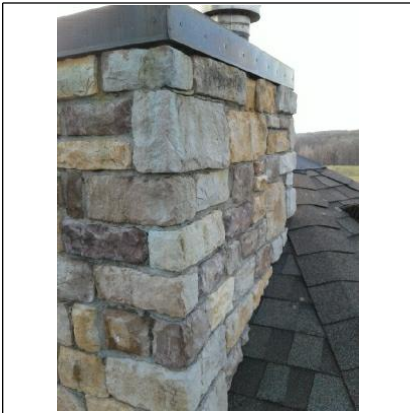
Chimneys Some maintenance may be needed around the cap a chimney there is some nails that are coming out should be pounded back in.

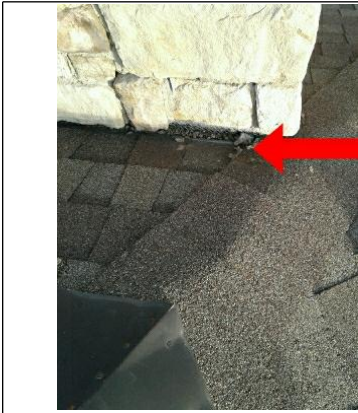
A small piece of brick maybe missing on the corner of the chimney.

There are a few loose Nails around the chimney cap. They should be pound it in.

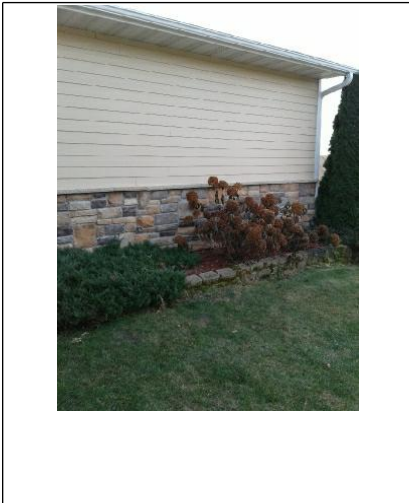
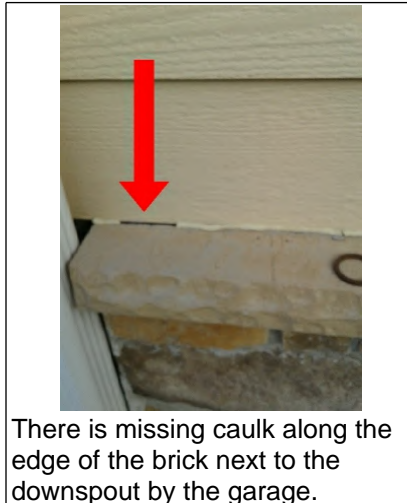
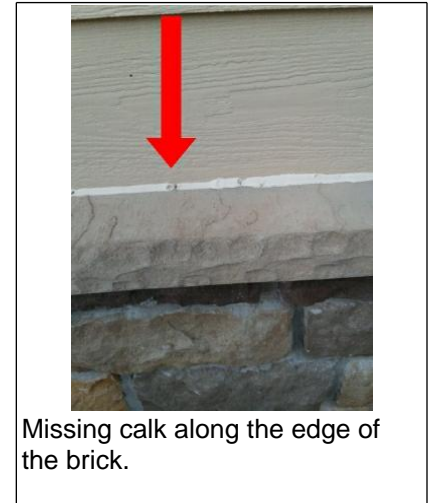
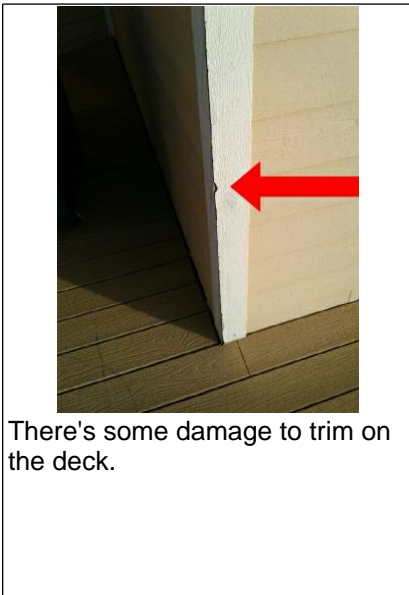
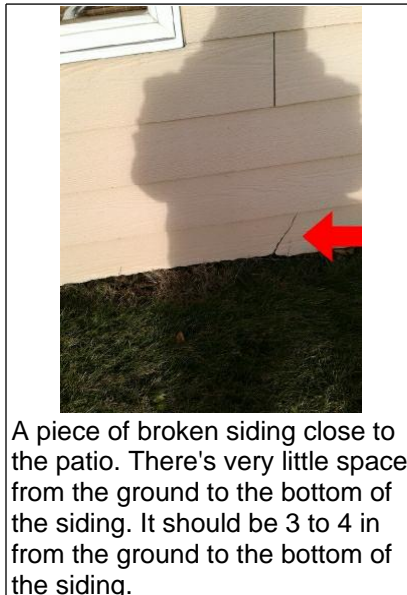
Wall covering There is no flashing between the siding and the brick facade . This creates a maintenance area . Make sure that good quality caulk is maintained between the brick and the wood siding .

Make sure that the caulk is maintained between the siding and the brick exterior. Missing calk could allow moisture to get in behind the brick and cause damage to the sheeting behind the brick.

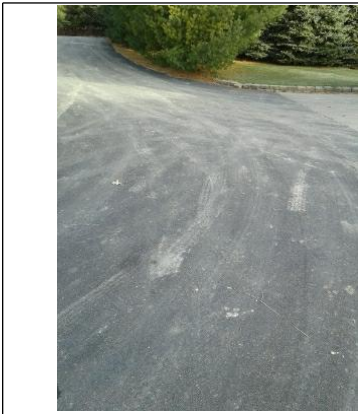
Entry driveways Marginal condition. The pad in front of the garage is cracked in several places.

Several cracks in the cement in front of the garage.

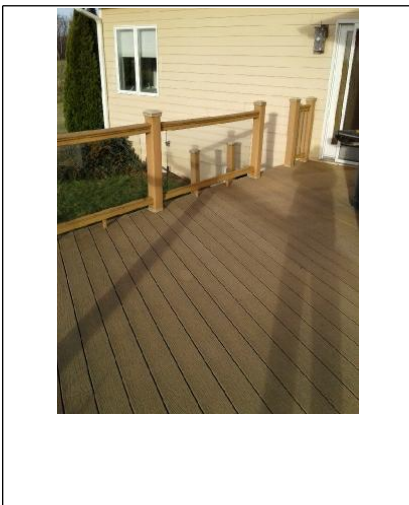
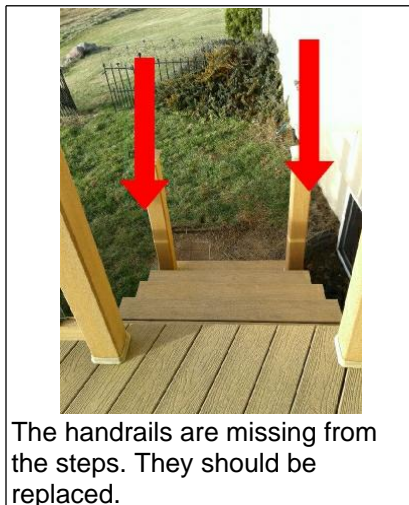
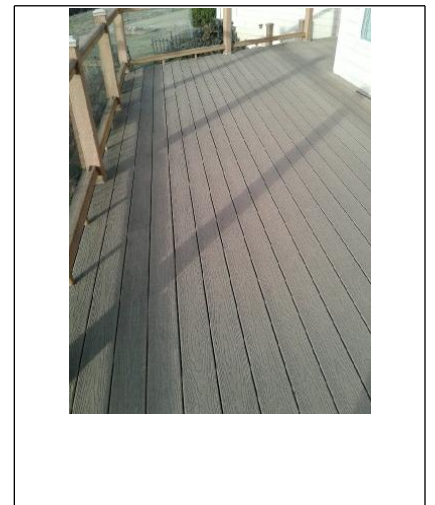
Porch / deck / steps / railings Satisfactory condition. The handrail should be replaced on the steps.

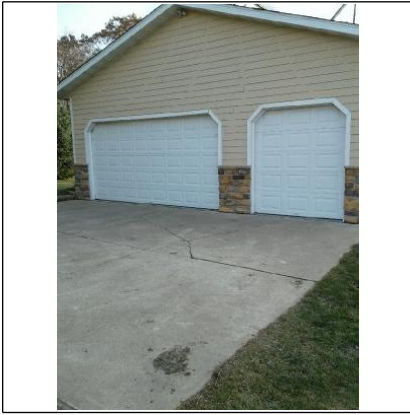
The automatic safety reverse on the large garage door is not working.
The automatic safety reverse the small garage door does not work.

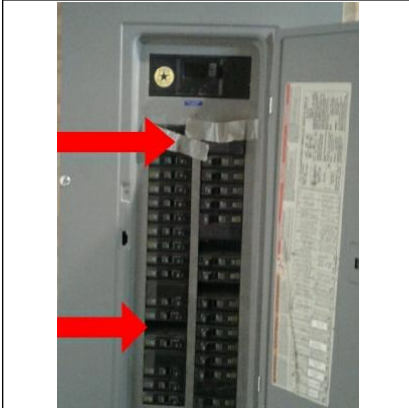
There are several missing Breakers in the Box. The Open Spaces should be filled in with blanks. The taped off Breakers at the top of the box we're for hot tubs which are no longer in the building.

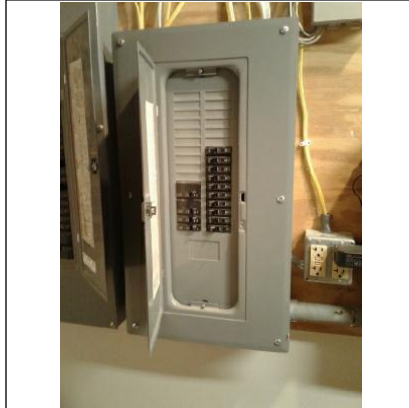
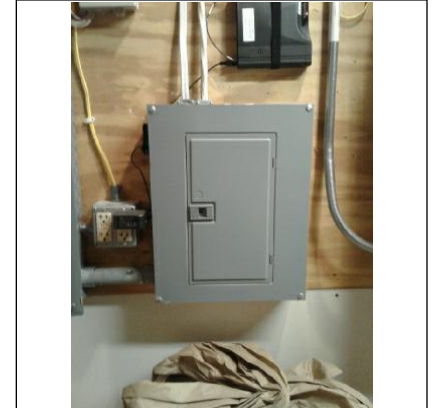
This box was put in for a generator. The generator has never been installed.

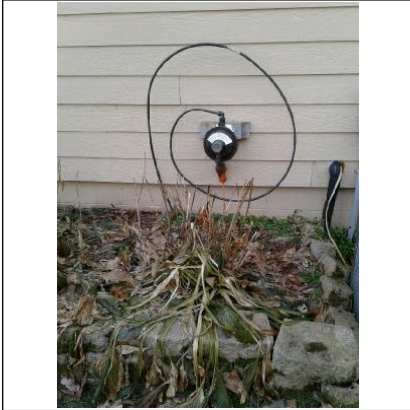
Energy source The copper piping to the house is longer than needed.

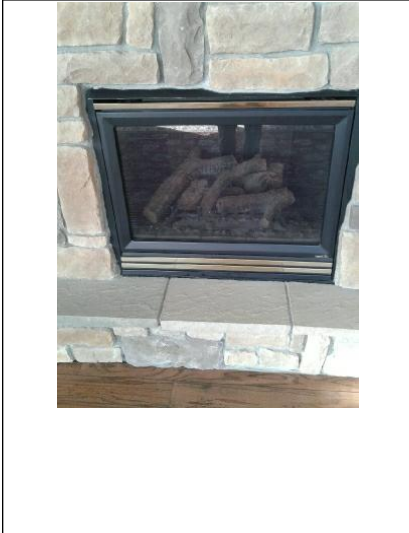
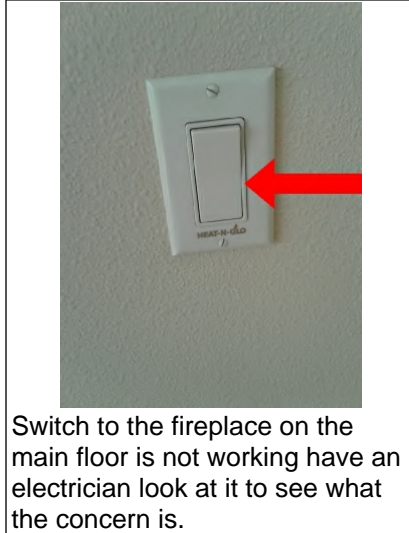
Description Gas fireplace on the main floor. The fireplace Burns correctly and is only controlled with the controls beneath the fireplace itself. The electronic switch to turn on the fireplace it's not working.

Switch to the fireplace on the main floor is not working have an electrician look at it to see what the concern is.
