Home Inspection Report

W1111 , Nelson , WI 54756

Monday November 20, 2017

1290

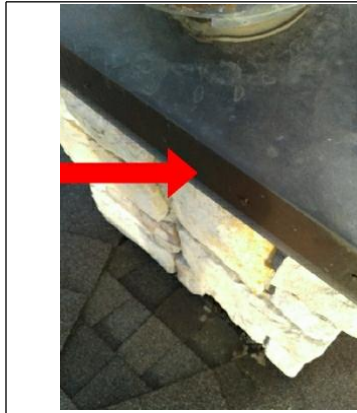
There are a few loose Nails around the chimney cap. They should be pound it in.

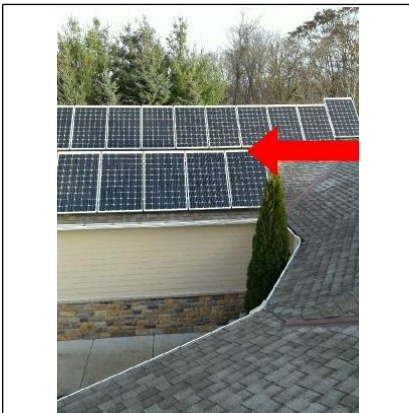
Bank of solar panels.
