Home Inspection Report

W1111 , Nelson , WI 54756

Monday November 20, 2017

1290

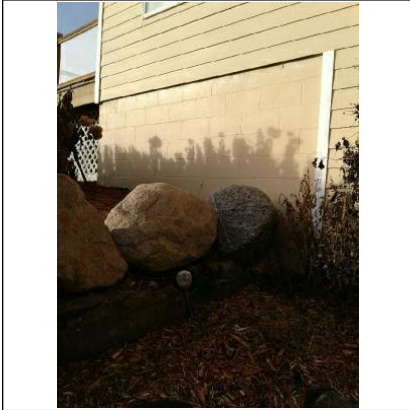
Foundation Satisfactory condition

- Masonry Block

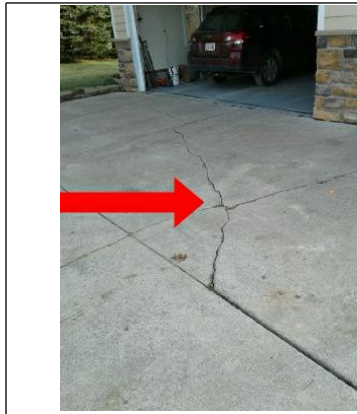
Entry driveways Marginal condition. The pad in front of the garage is cracked in several places.

Several cracks in the cement in front of the garage.

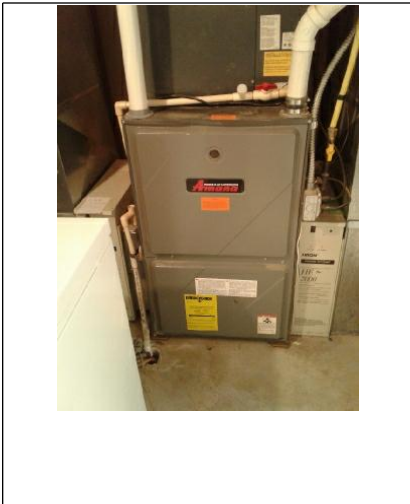
System type Satisfactory condition . The forced air furnace responded correctly to the thermostat .

The furnace has a nice blue flame and appears to be working correctly.

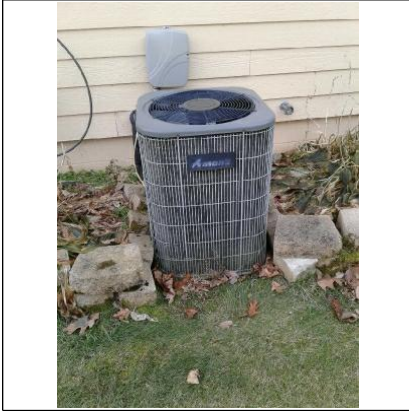
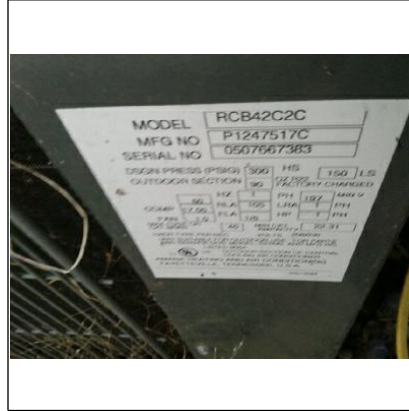
The air conditioning unit was not run because of the cold weather. The air conditioning unit is about 12 years old its original to the home.

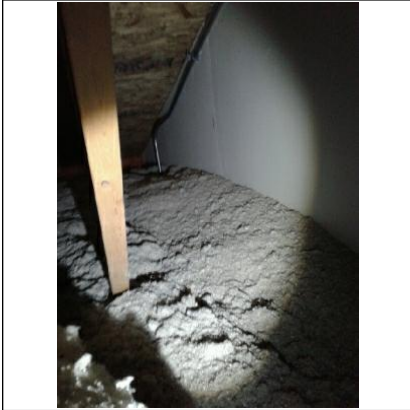
Attic 14 inches of blown in insulation over the entire house. There's about 12 in over the garage. This gives an R-factor for the home of about 38.

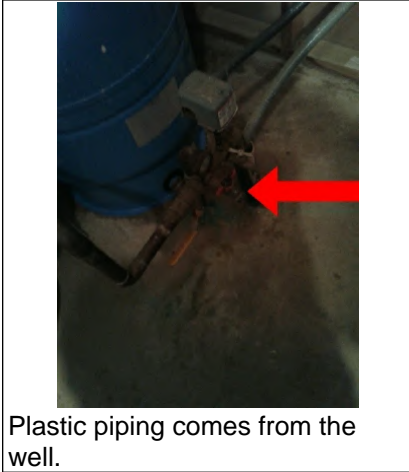
Water supply source Water test should be taken by a POWTS inspector .
• Private Water Supply

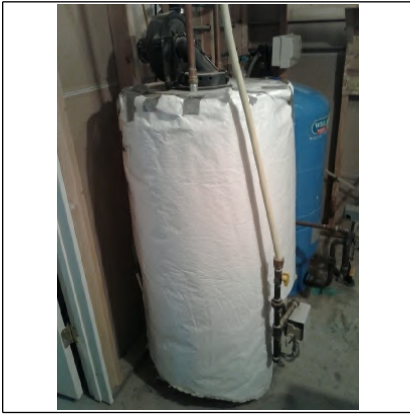
Water heater 52 gallon Bradford White Water Heater . Its original to the home it's about 12 years old .

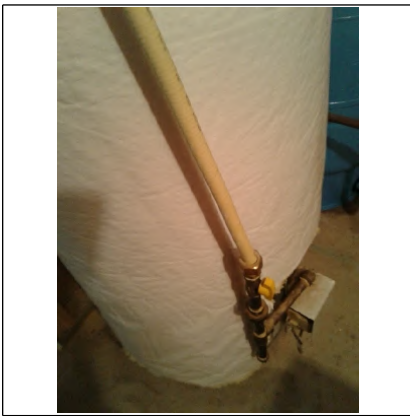
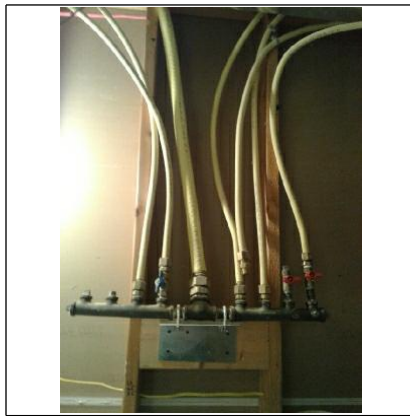
Fuel storage / distribution Satisfactory condition

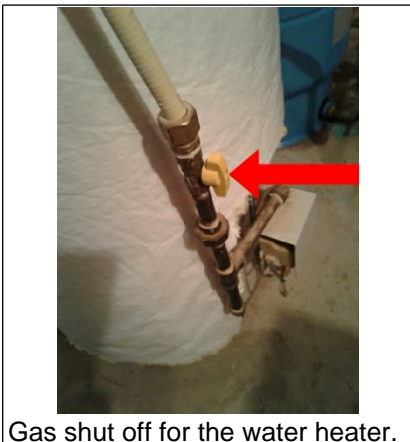
Fuel shut-off valves Satisfactory condition

Gas shut off for the water heater.

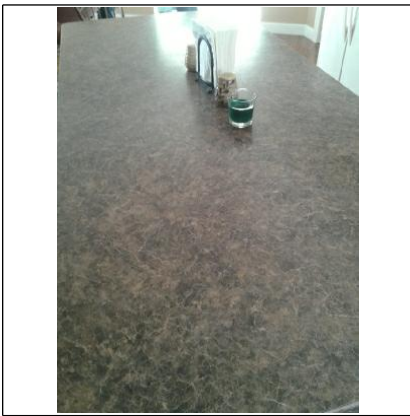
Kitchen counters Satisfactory condition

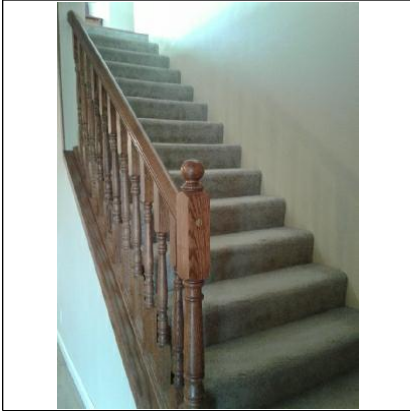
Stairways Satisfactory condition

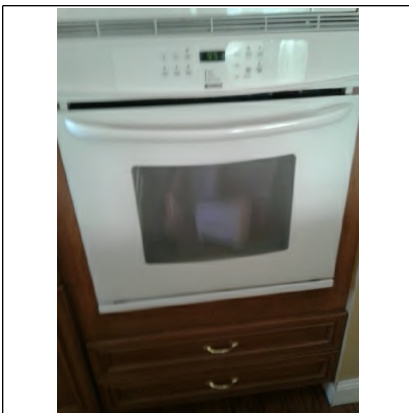
Oven Satisfactory condition

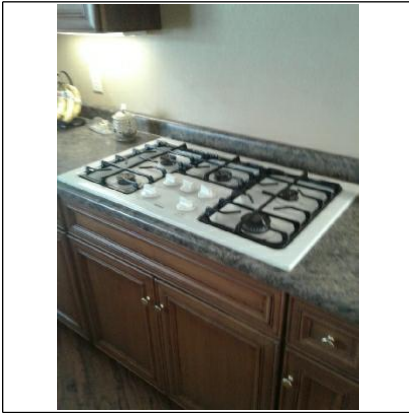
Gas cooktop unit Satisfactory condition

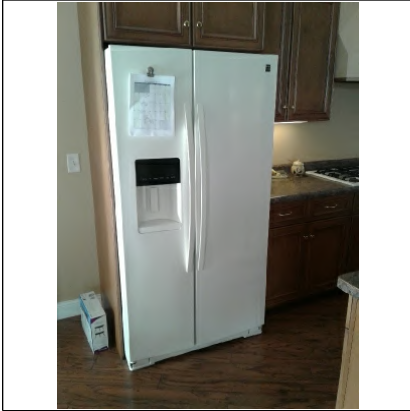
Refrigerator unit Indoor unit purchased in the last 12 months. Satisfactory condition

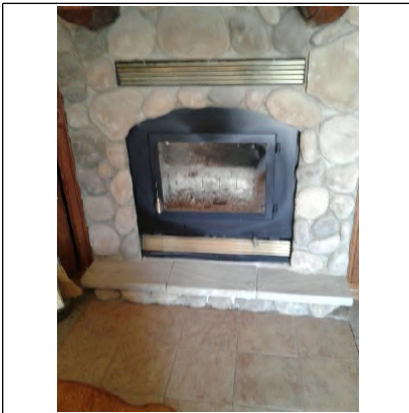
Fireplace Wood fireplace in the family room in the basement. Satisfactory condition
